## Spooky Urolith Centers

This month we are focusing on the interesting, strange and scary things we have found in the center of uroliths.

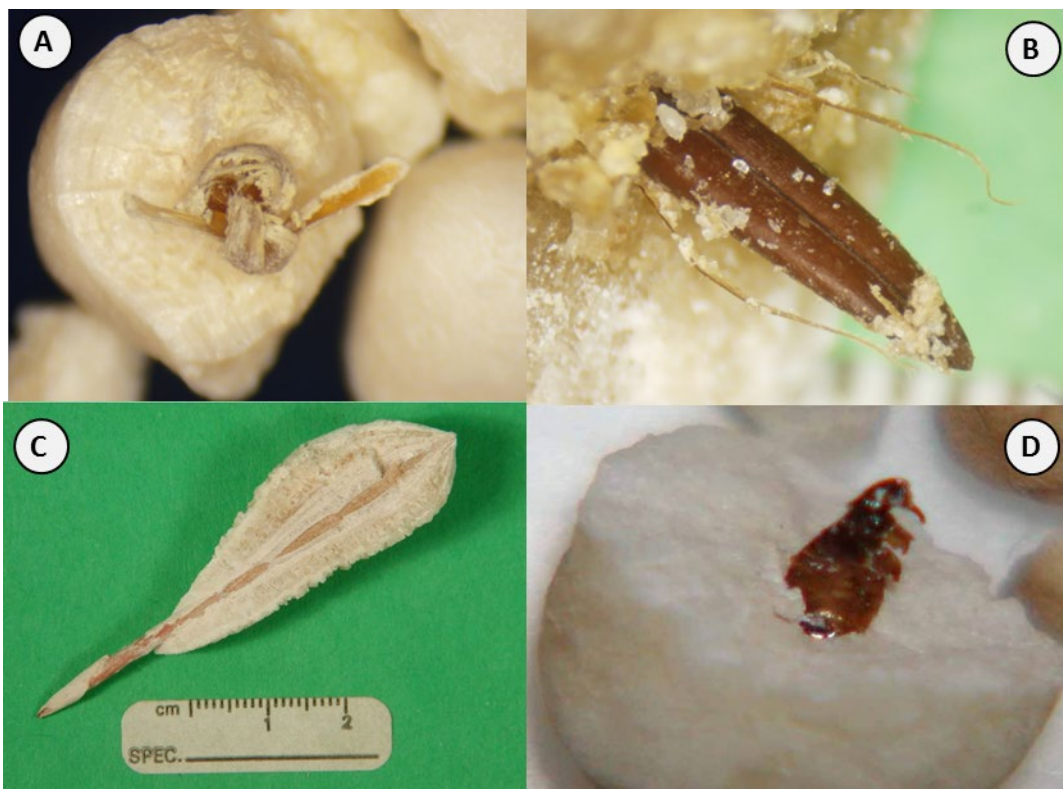
- Suture was identified in approximately 10% of recurrent stones. When closing the bladder after a cystotomy, minimize placing suture in the bladder lumen to reduce its contribution to stone recurrence. **Image A**
- Plant awns/material are common in the western United States and sometimes enter the bladder and can become encrusted with mineral. **Image B**
- Toothpick - a migrating toothpick could have been swallowed by the pet because it held a tasty Halloween treat. In this case, the toothpick pierced the intestine, traveled to the bladder and initiated stone formation. **Image C**
- Fleas, louse, and other insects may climb up the urethra and become entombed in stones. **Image D**

Heterogeneous nucleation: the process where crystallization is enhanced by initiating over foreign-preformed surfaces.
